Tetraamine Copper Nitrate (TACN)

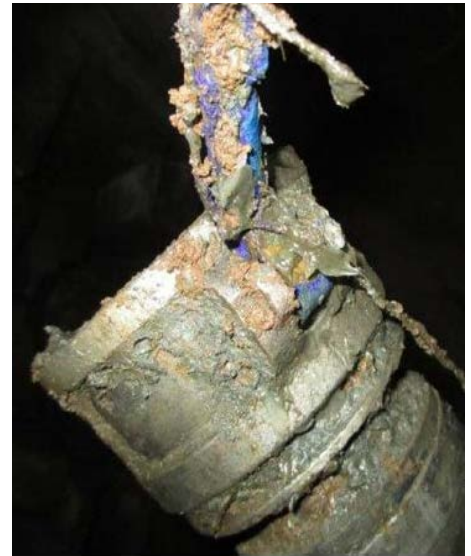
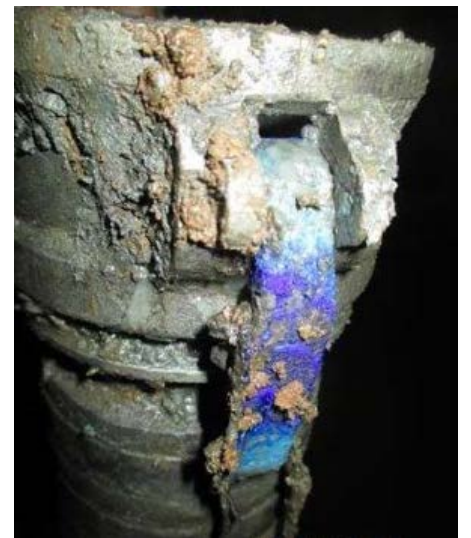
Commonly, a deep blue copper nitrate corrosion is found on copper in these environments. However, there is also the risk for TACN to form on copper-containing components in these same environments. Its deep purple colour can identify TACN and the salt crystals it produces, which, when in a dry crystallized form are highly unstable and susceptible to impact, leading to a very high risk of explosion. *See photos¹ – TACN forming on copper-containing brass lever clamps.*

- Avoid the use of equipment that contains copper or copper alloys; consider using alternative metals such as stainless steel or aluminum
- If there is no way to avoid the use of copper, follow good house-keeping practices by regularly inspecting and cleaning equipment to ensure TACN formation is prevented
- Develop a safe work procedure for employees who work in environments where TACN may be encountered
- Train workers to identify and handle TACN correctly and safely
